# 1972: L1011 Miami

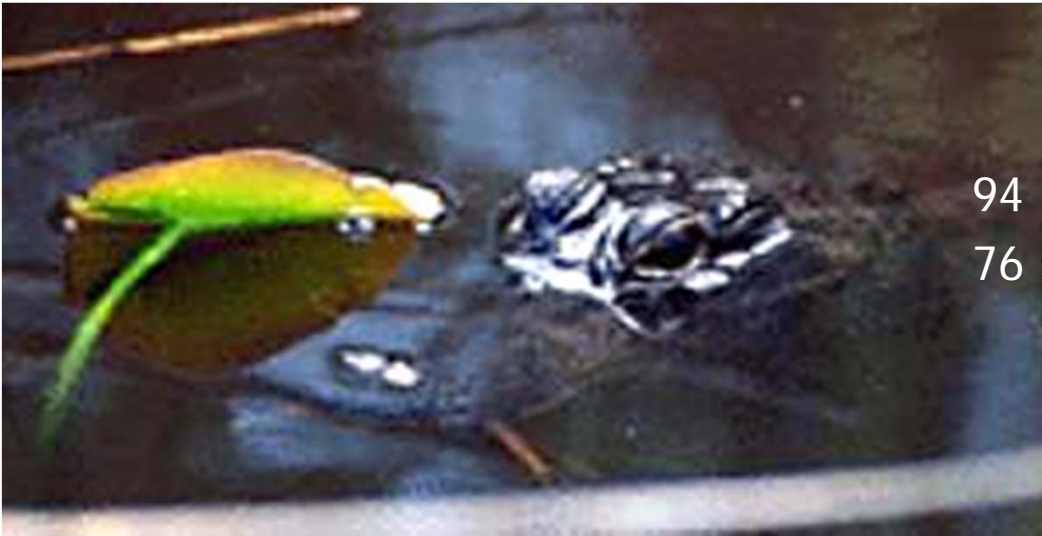
- Accident causes (NTSB conclusion )
  - Failure of the crew:
    - To monitor instruments during the last 4 minutes of flight,
    - To detect descend in order to prevent ground collision

94 pax et 5 crew died  
76 survivors
