1990: BAC1-11 Southampton

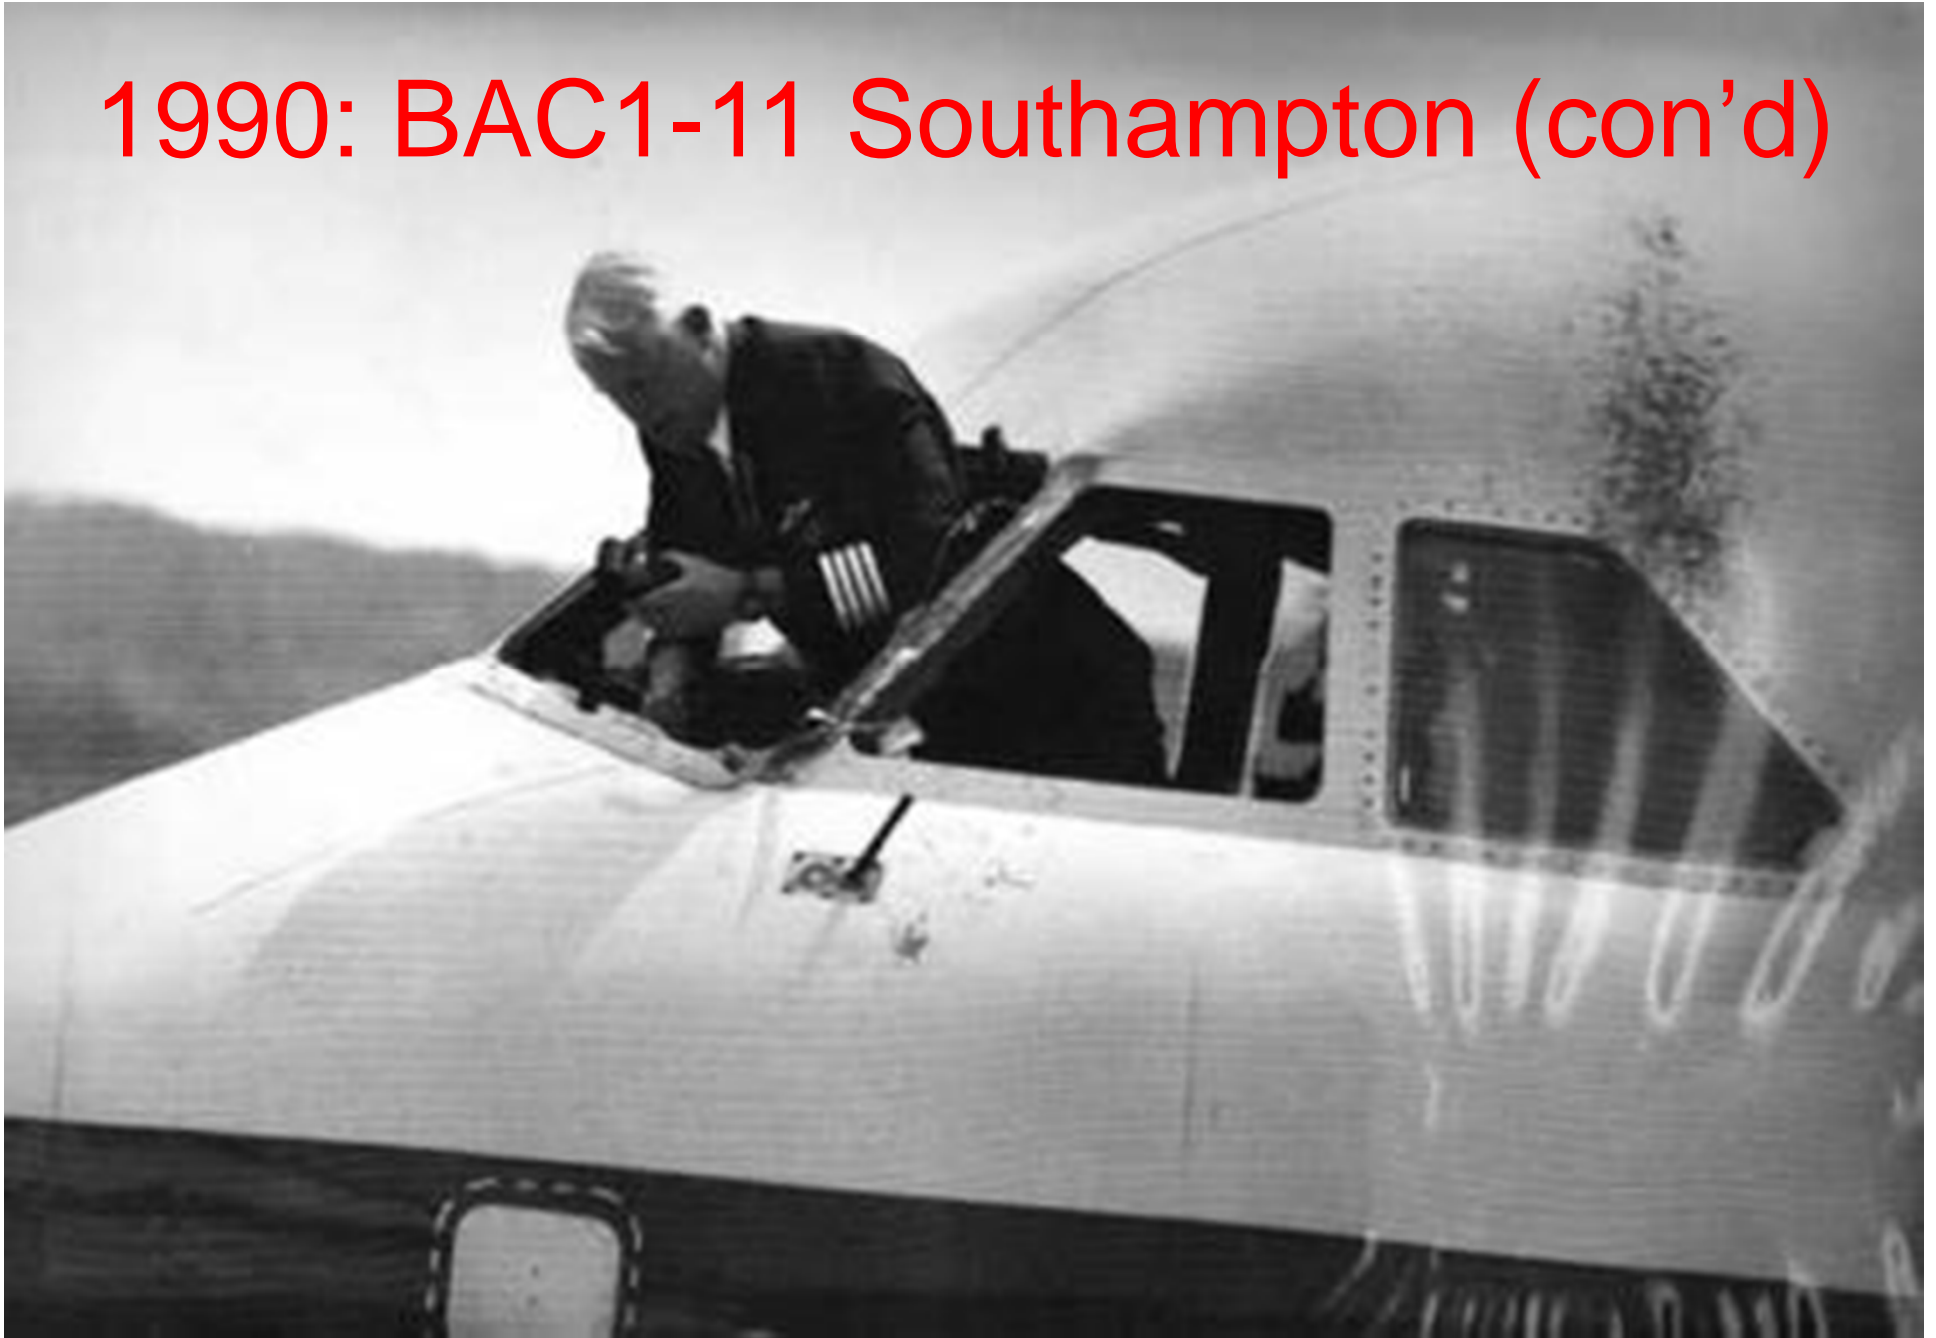
- Pax shocked but unhurt
- Captain:
 - ➔ Broken
 - × Right arm
 - × Wrist
 - × Left thumb
 - ➔ Bruising
 - ➔ Frostbite
- Cabin attendant
 - ➔ Suffered from frostbite and bruising
- Aircraft
 - ➔ Left windscreen missing.

- The windscreen had been **replaced** just 24 hours before the flight,
- **Wrong size bolts** (90) were used to fit the new window
- Although the difference in size was minimal (**1/10 mm below** the required diameter), it was enough to cause the windscreen to blow out.
