1998: B1900D Quiberon

■ General context

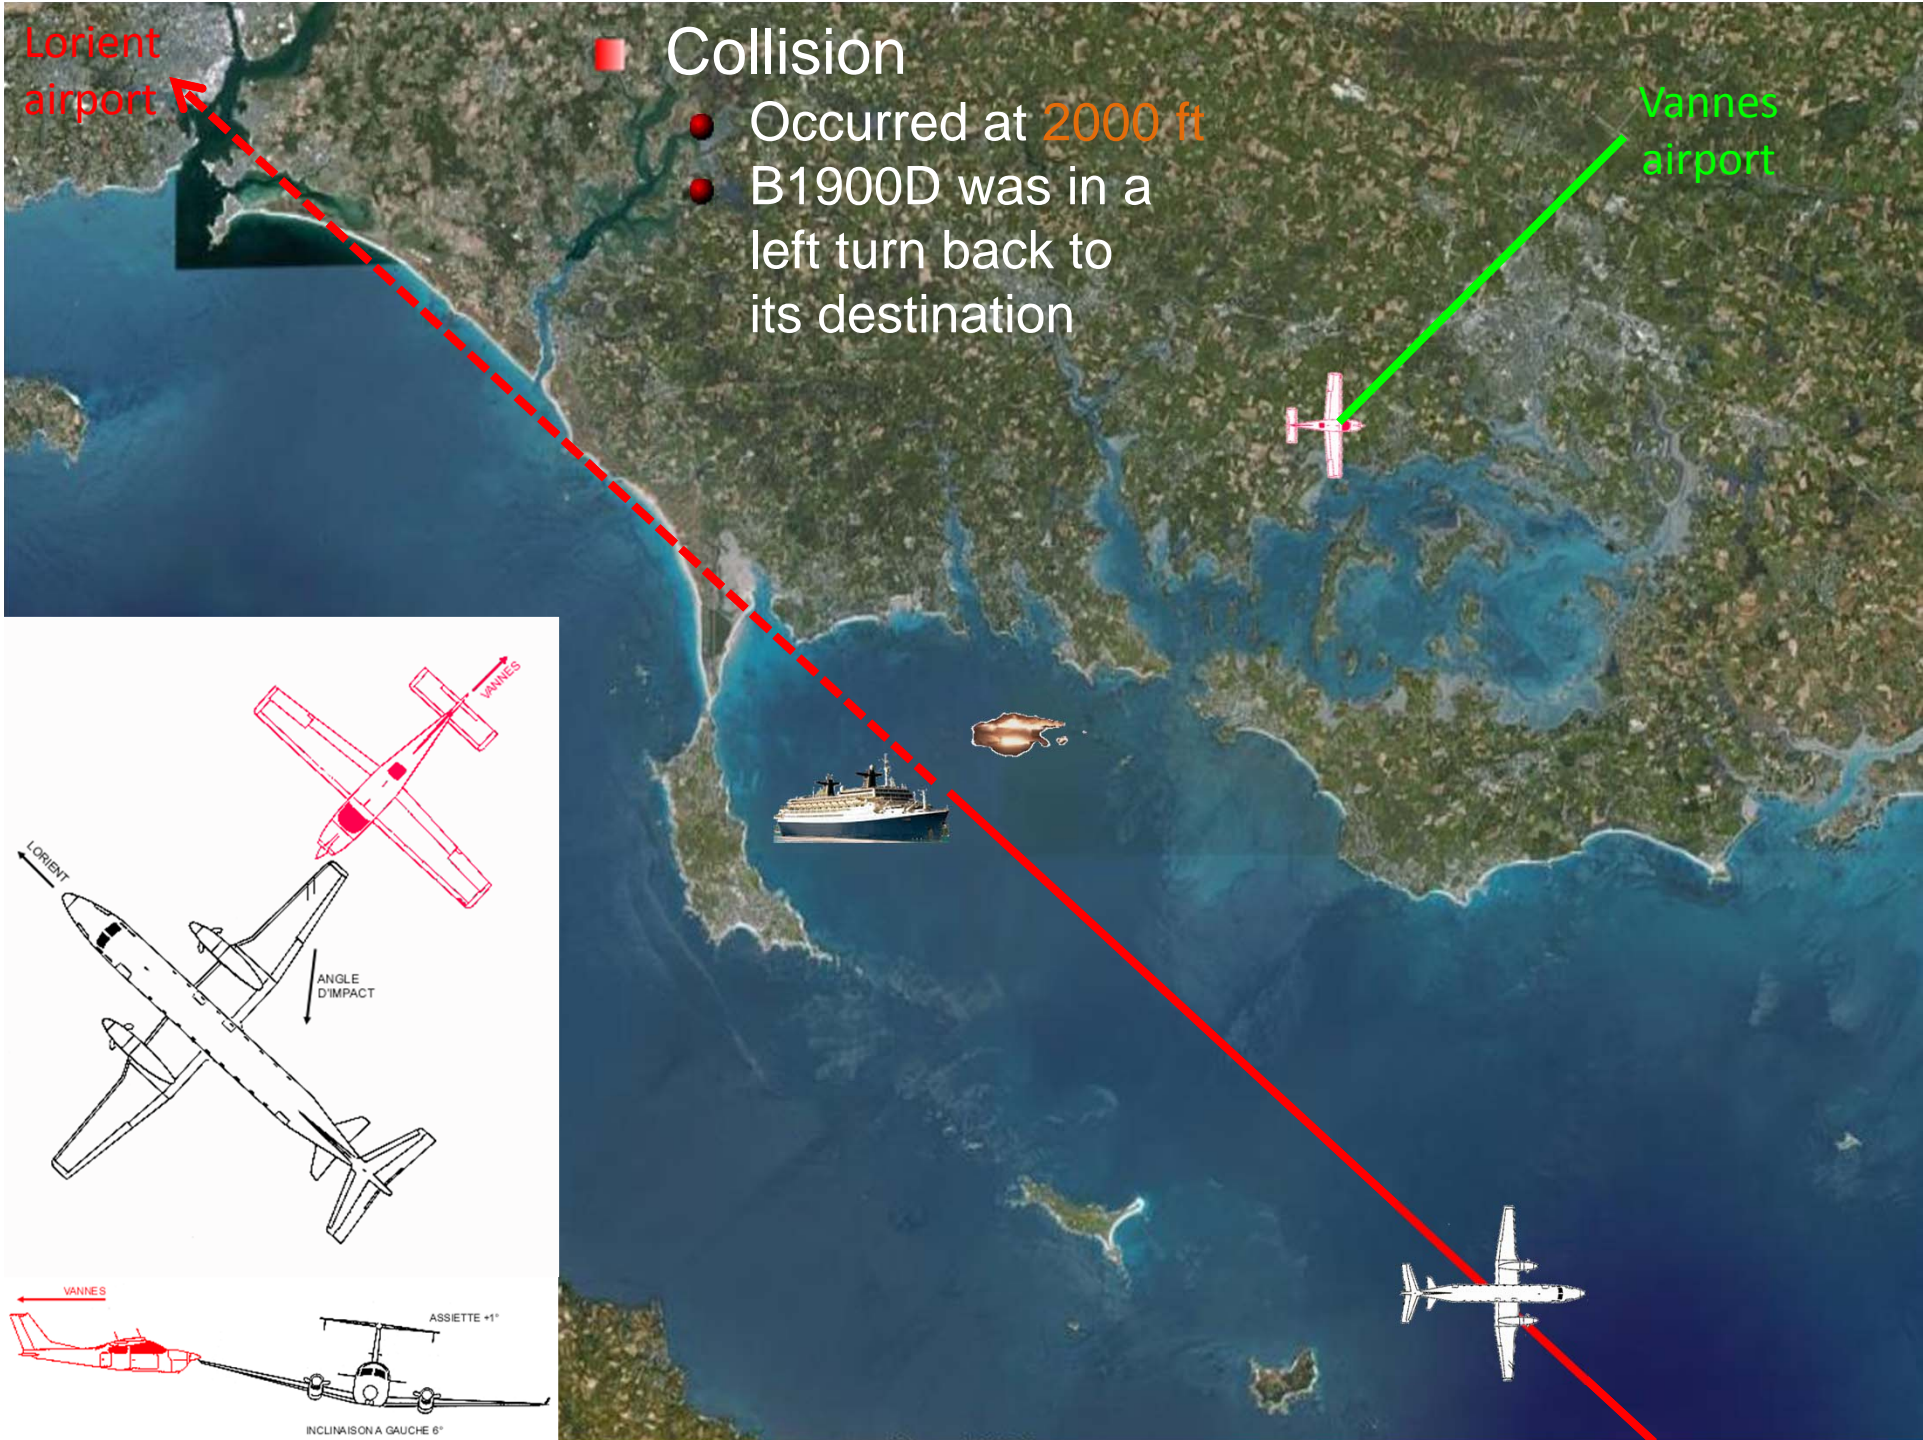
Lorient
airport

Collision

- Occurred at 2000 ft
- B1900D was in a left turn back to its destination

Vannes
airport
