2005: A340 Toronto

■ General Context

- Scheduled passenger flight Paris-Toronto
- 12 crew members
- 297 pax
- Bad weather at Toronto:
 - × Localized TS
 - × Heavy RA
 - × Severe winds

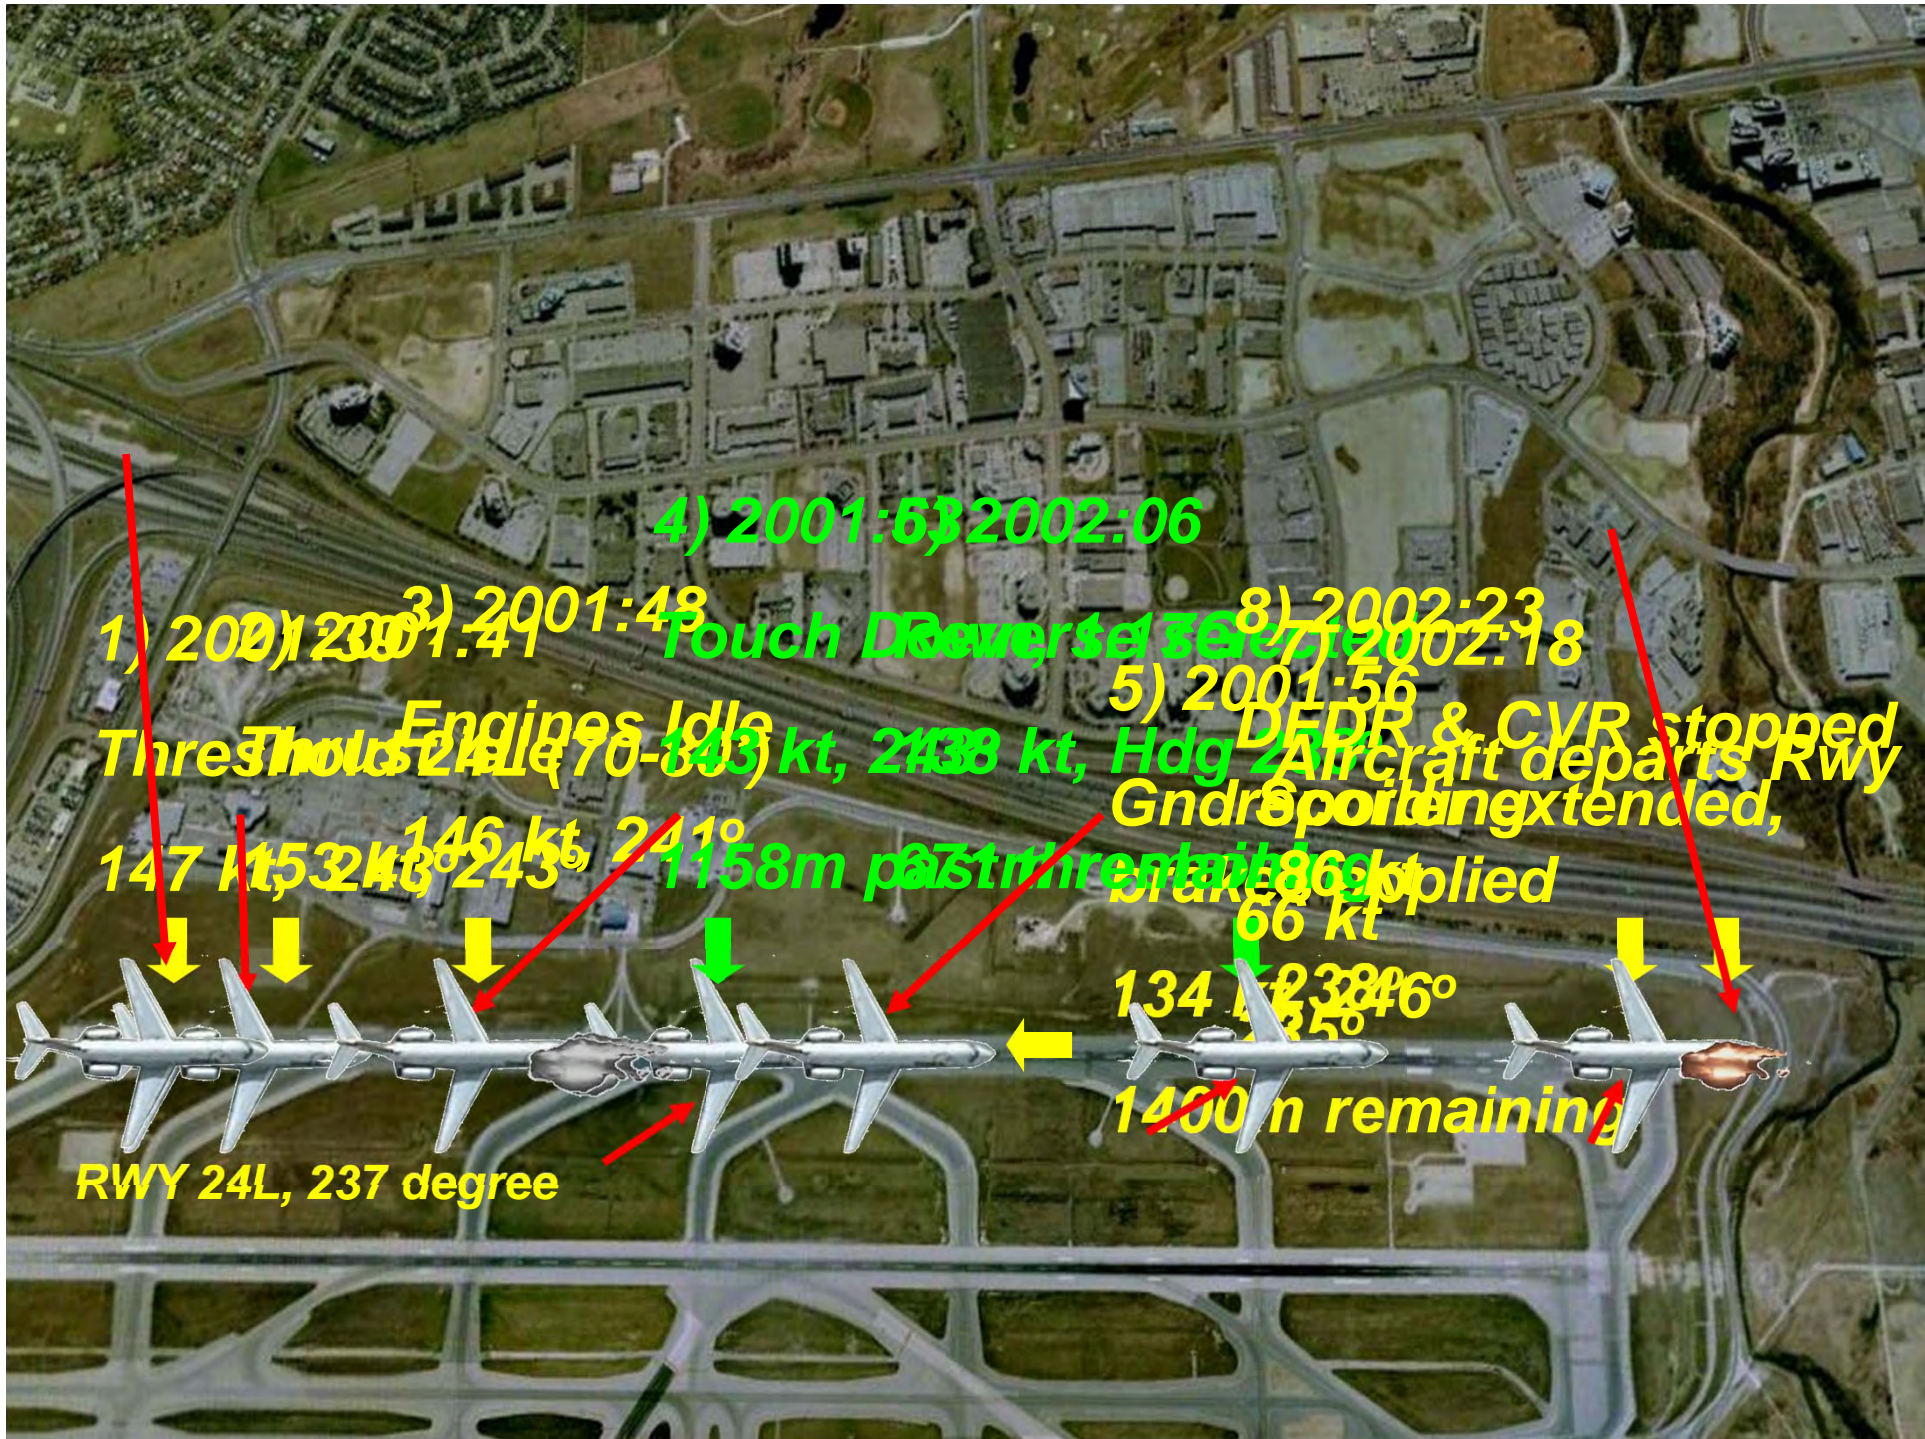
RWY 24L, 237 degree

● RWY 24L:

- ➔ The shortest RWY in Toronto
- ➔ Breaking action reported “poor” by previous A/C

- ➔ Almost **mid** runway (1220m for a 2743m RWY)

1) 2001:23
 2) 2001:39
 3) 2001:41
 4) 2001:53
 5) 2001:56
 6) 2001:57
 7) 2002:06
 8) 2002:18
 9) 2002:23

Engines Idle
 Thrust 24%
 147 kt
 153 kt
 146 kt
 243 kt
 241°
 1158m
 Touch Down
 Reverse
 35°
 2002:18
 DEDR & CVR stopped
 Aircraft departs Rwy
 Gndspoiler extended,
 Spoiler applied
 86 kt
 66 kt
 134 kt
 238°
 250°
 246°
 1400 m remaining

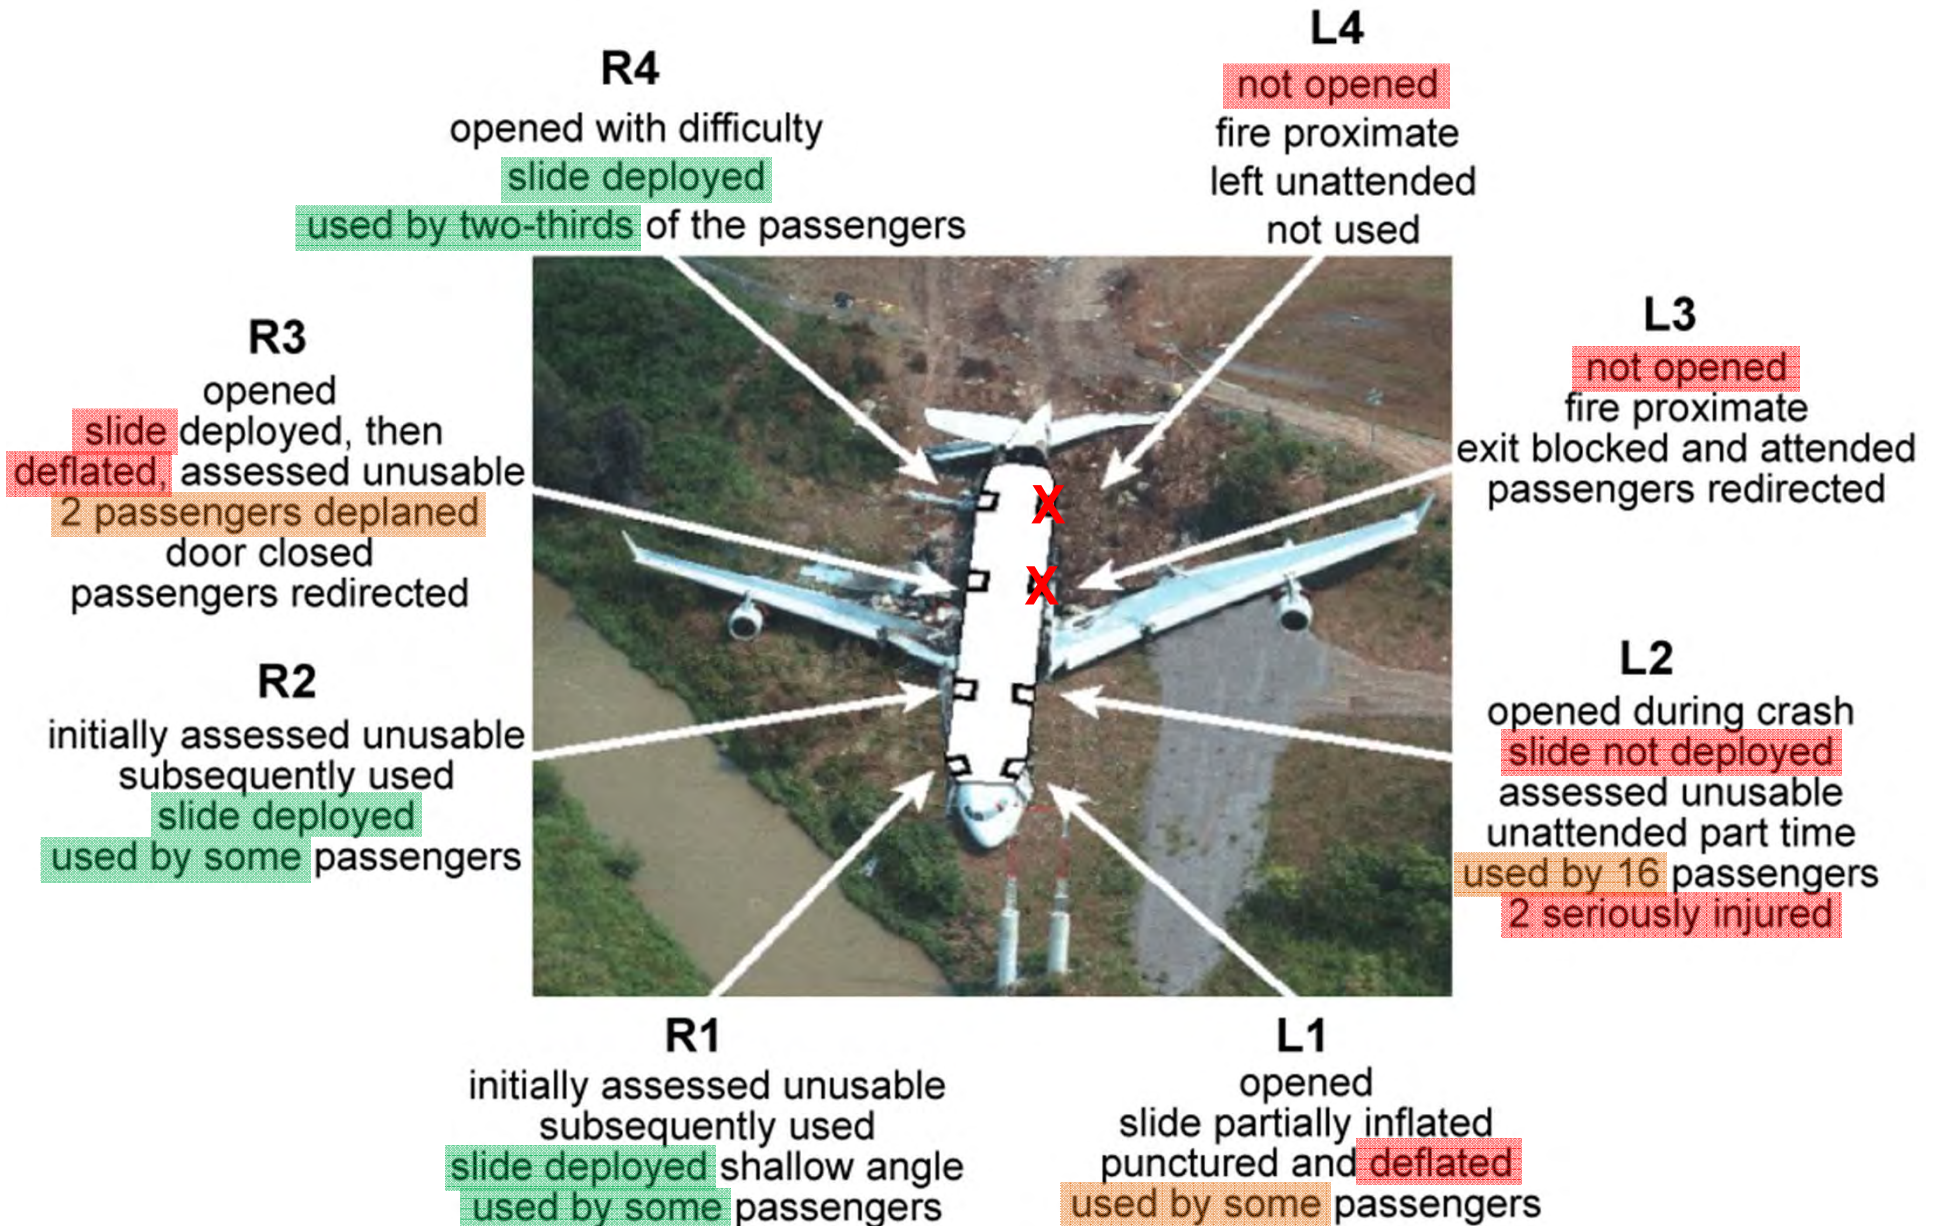
- After the aircraft stopped, flight attendants:
 - Observed a fire outside the aircraft
 - Order the evacuation.
- Many passengers took carry-on luggage during evacuation
- The complete evacuation was effected in less than 2 mn.
- Assisted by airport Emergency Response Services (ERS)

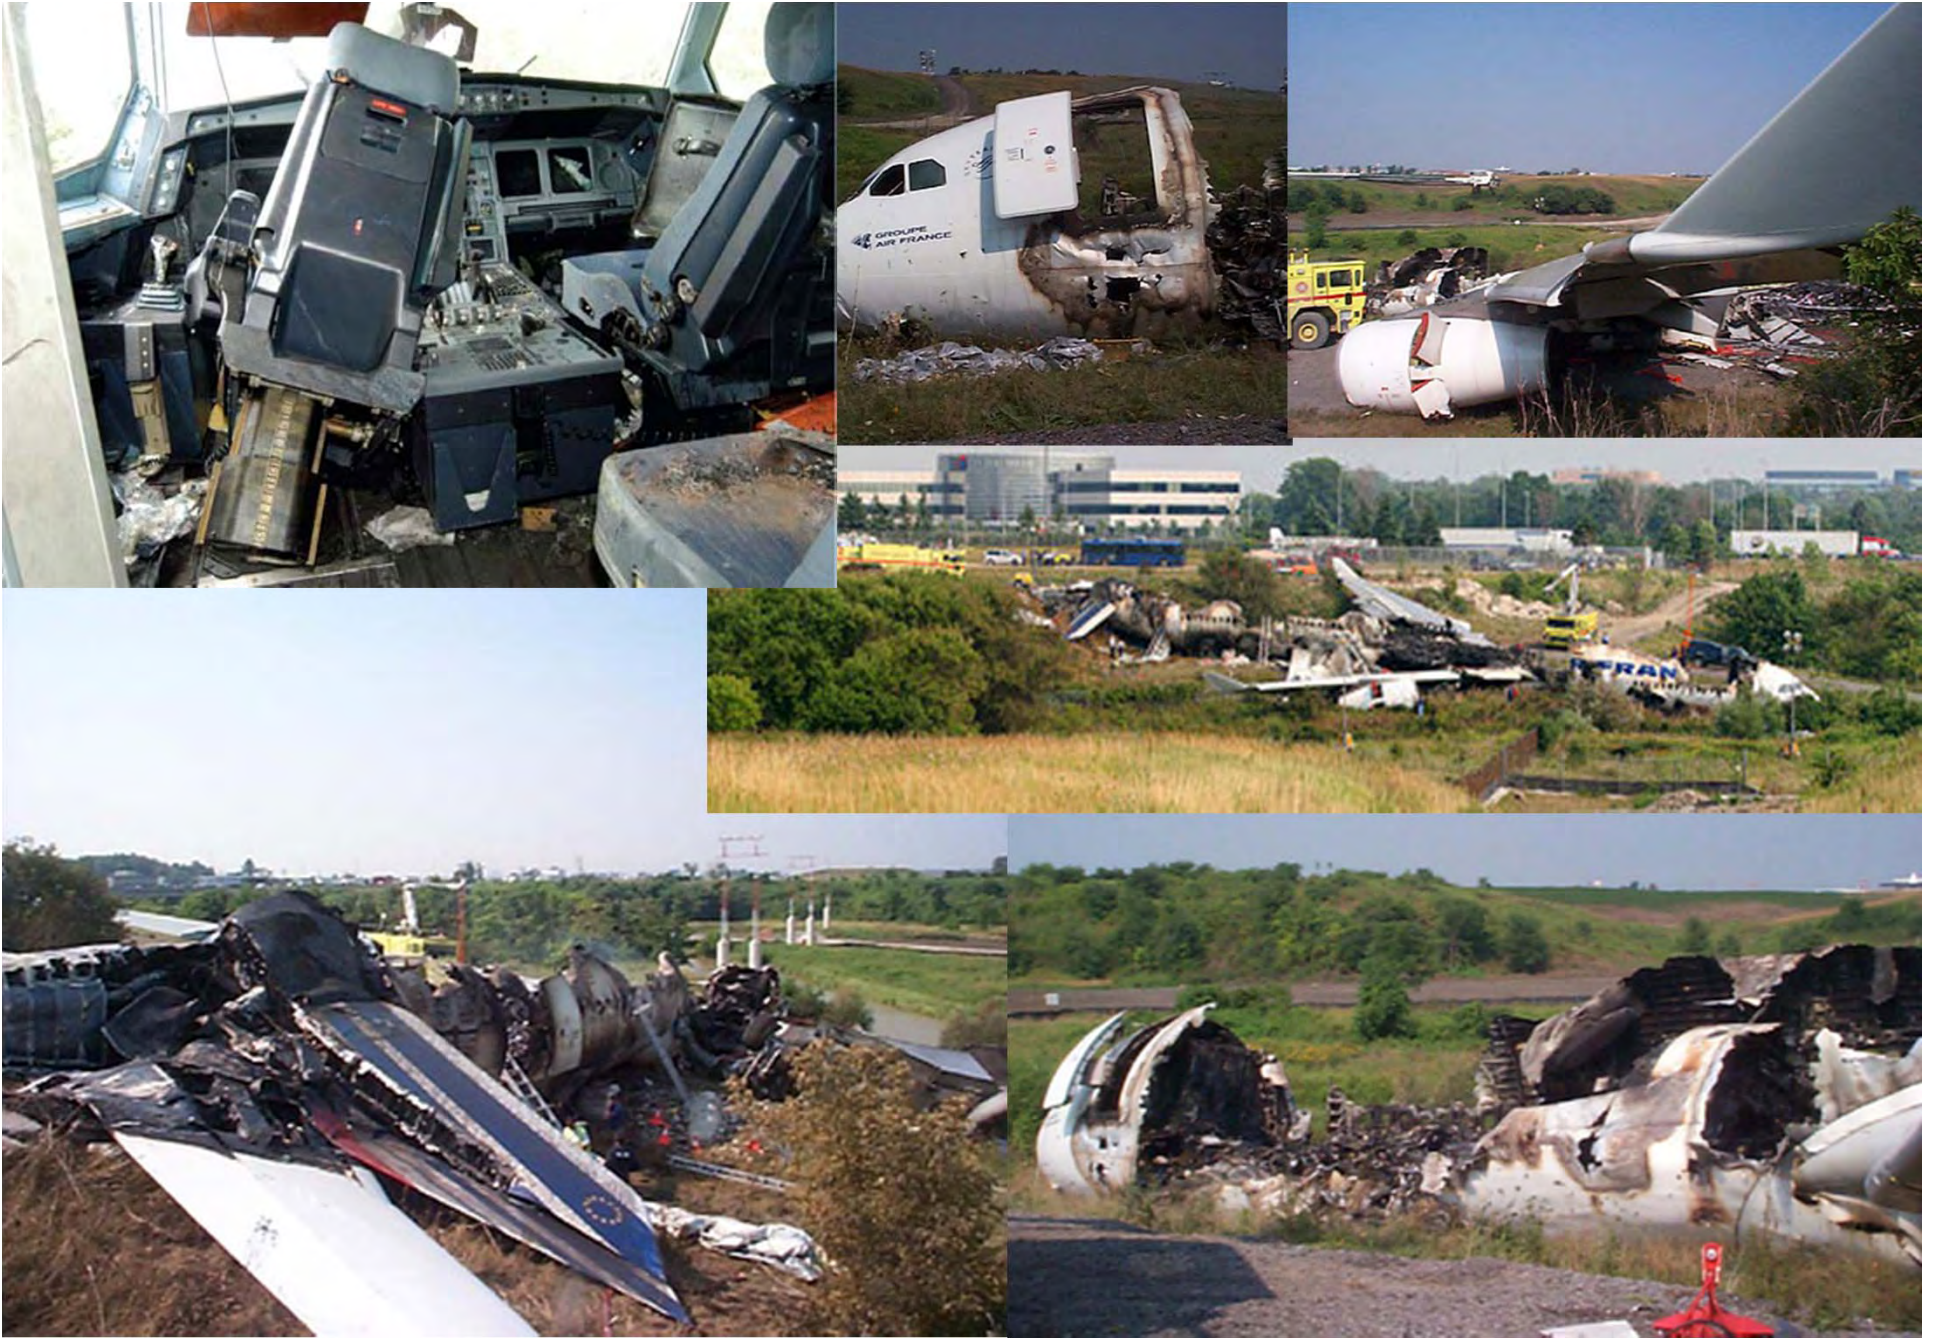
- The following factors did not allow aircraft to stop before the end of RWY:
 1. Extra thrust
 2. Tail wind
 3. 12" time before using reverses
 4. RWY contaminated (braking action poor).
