2005: A340 Toronto

■ General Context

- Scheduled passenger flight Paris-Toronto
- 12 crew members
- 297 pax
- Bad weather at Toronto:
 - × Localized TS
 - × Heavy RA
 - × Severe winds

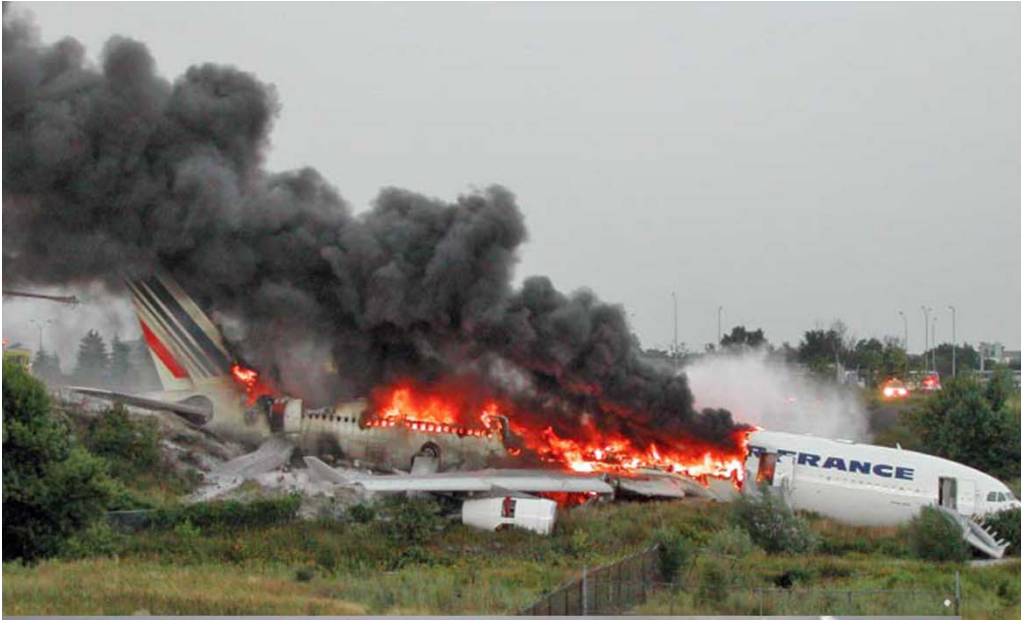
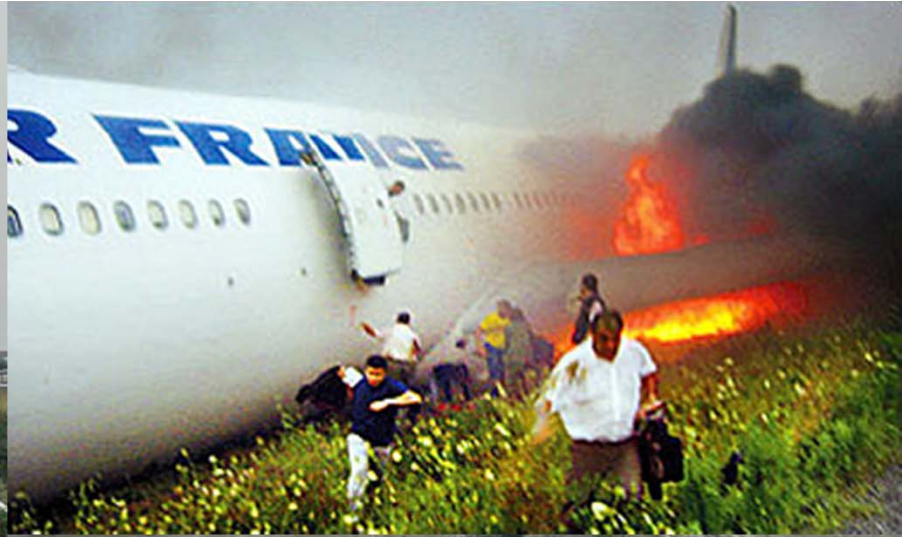
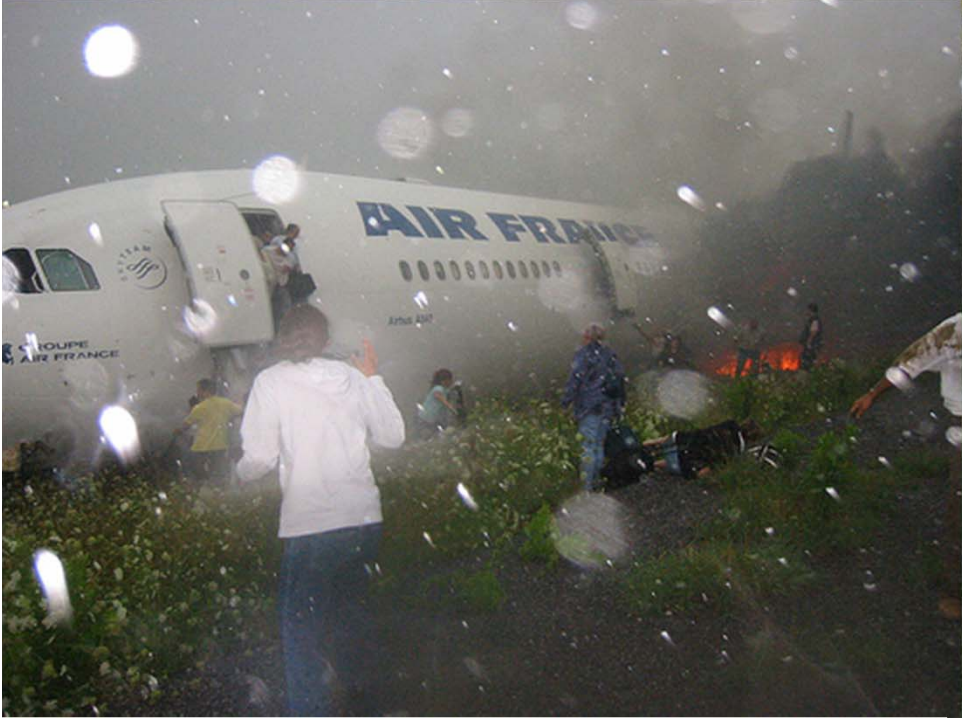
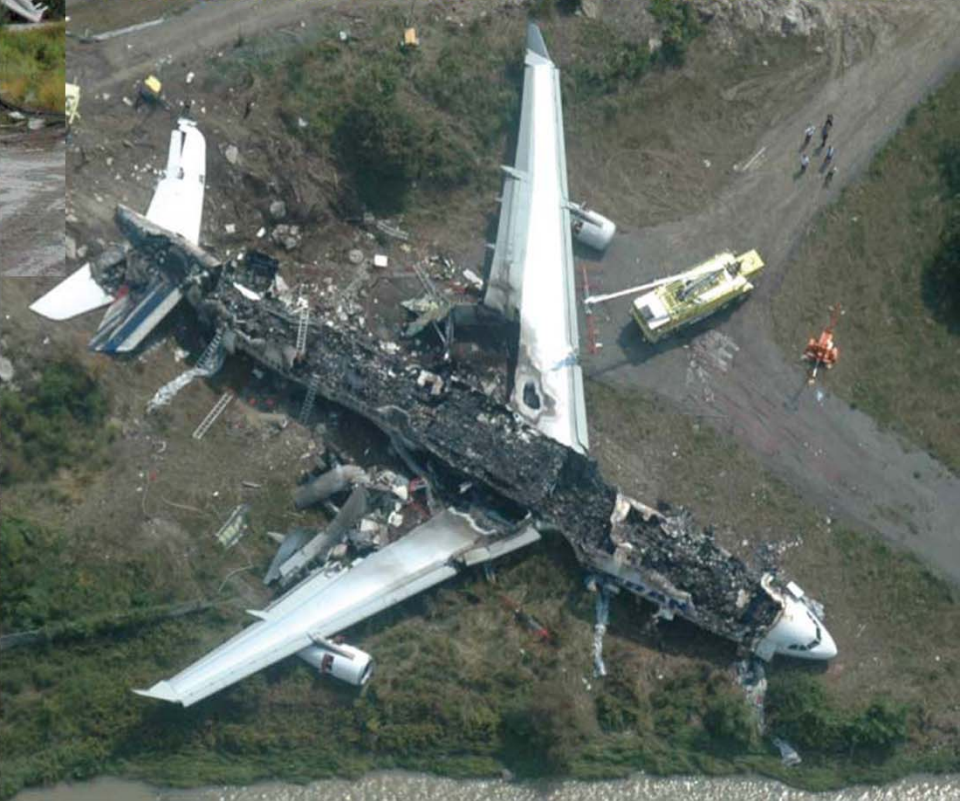
- After the aircraft stopped, flight attendants:
 - Observed a fire outside the aircraft
 - Order the evacuation.
- Many passengers took carry-on luggage during evacuation
- The complete evacuation was effected in less than 2 mn.
- Assisted by airport Emergency Response Services (ERS)

- 21 persons received minor injuries
- 2 crews and 10 pax received serious injuries
- No fatalities
- A/C substantially damaged then destroyed by post-crash fire
- Hundred of flights were diverted.

- The following factors did not allow aircraft to stop before the end of RWY:
 1. Extra thrust
 2. Tail wind
 3. 12" time before using reverses
 4. RWY contaminated (braking action poor).
